Item No.: 18A-RR-01

NCUTCD Proposal for Changes to the Manual on Uniform Traffic Control Devices

TECHNICAL COMMITTEE: RRLRT Technical Committee
ITEM NUMBER: 18A-RR-01
TOPIC: Another Train Coming
ORIGIN OF REQUEST: RRLRT Technical Committee
AFFECTED SECTIONS OF MUTCD: New Section 8C.XX (following 8C.07 Wayside Horn Systems)

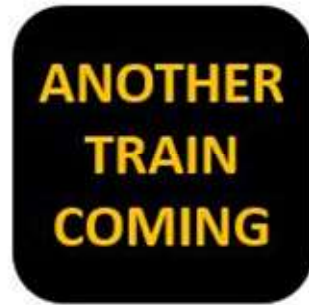
Example 1

67
68 An ANOTHER TRAIN COMING (Example 1) train-activated blank-out warning sign may be
69 used to warn of the approach of another train. The sign may be phased (flashed) in accordance
70 with Section 2L when activated, and may be supplemented with an audible sound which is
71 distinguishable from a normal railroad crossing bell, or with a verbal message.

72
73 The ANOTHER TRAIN COMING sign may be mounted on a flashing light signal support
74 below the flashing lights, on a separate support adjacent to the flashing lights, or on the back side
75 of a flashing light signal support on the left side of the grade crossing. If there are no flashing
76 lights, the sign may be installed where flashing lights would otherwise be located, or at a location
77 determined by the diagnostic team to have adequate visibility which may include mounting on
78 traffic signal infrastructure.
